Corrective Actions and Rehabilitation Plan Market Road Landfill Brooklyn, VIC

August 2013

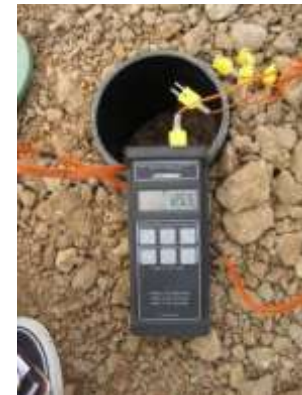
The site characterisation activities commenced immediately and included:

- Visual surveys
- Aerial thermal and infra-red imaging
- Subsurface temperature monitoring
- Air and emissions monitoring
- Perimeter demarcation
- Daily reporting

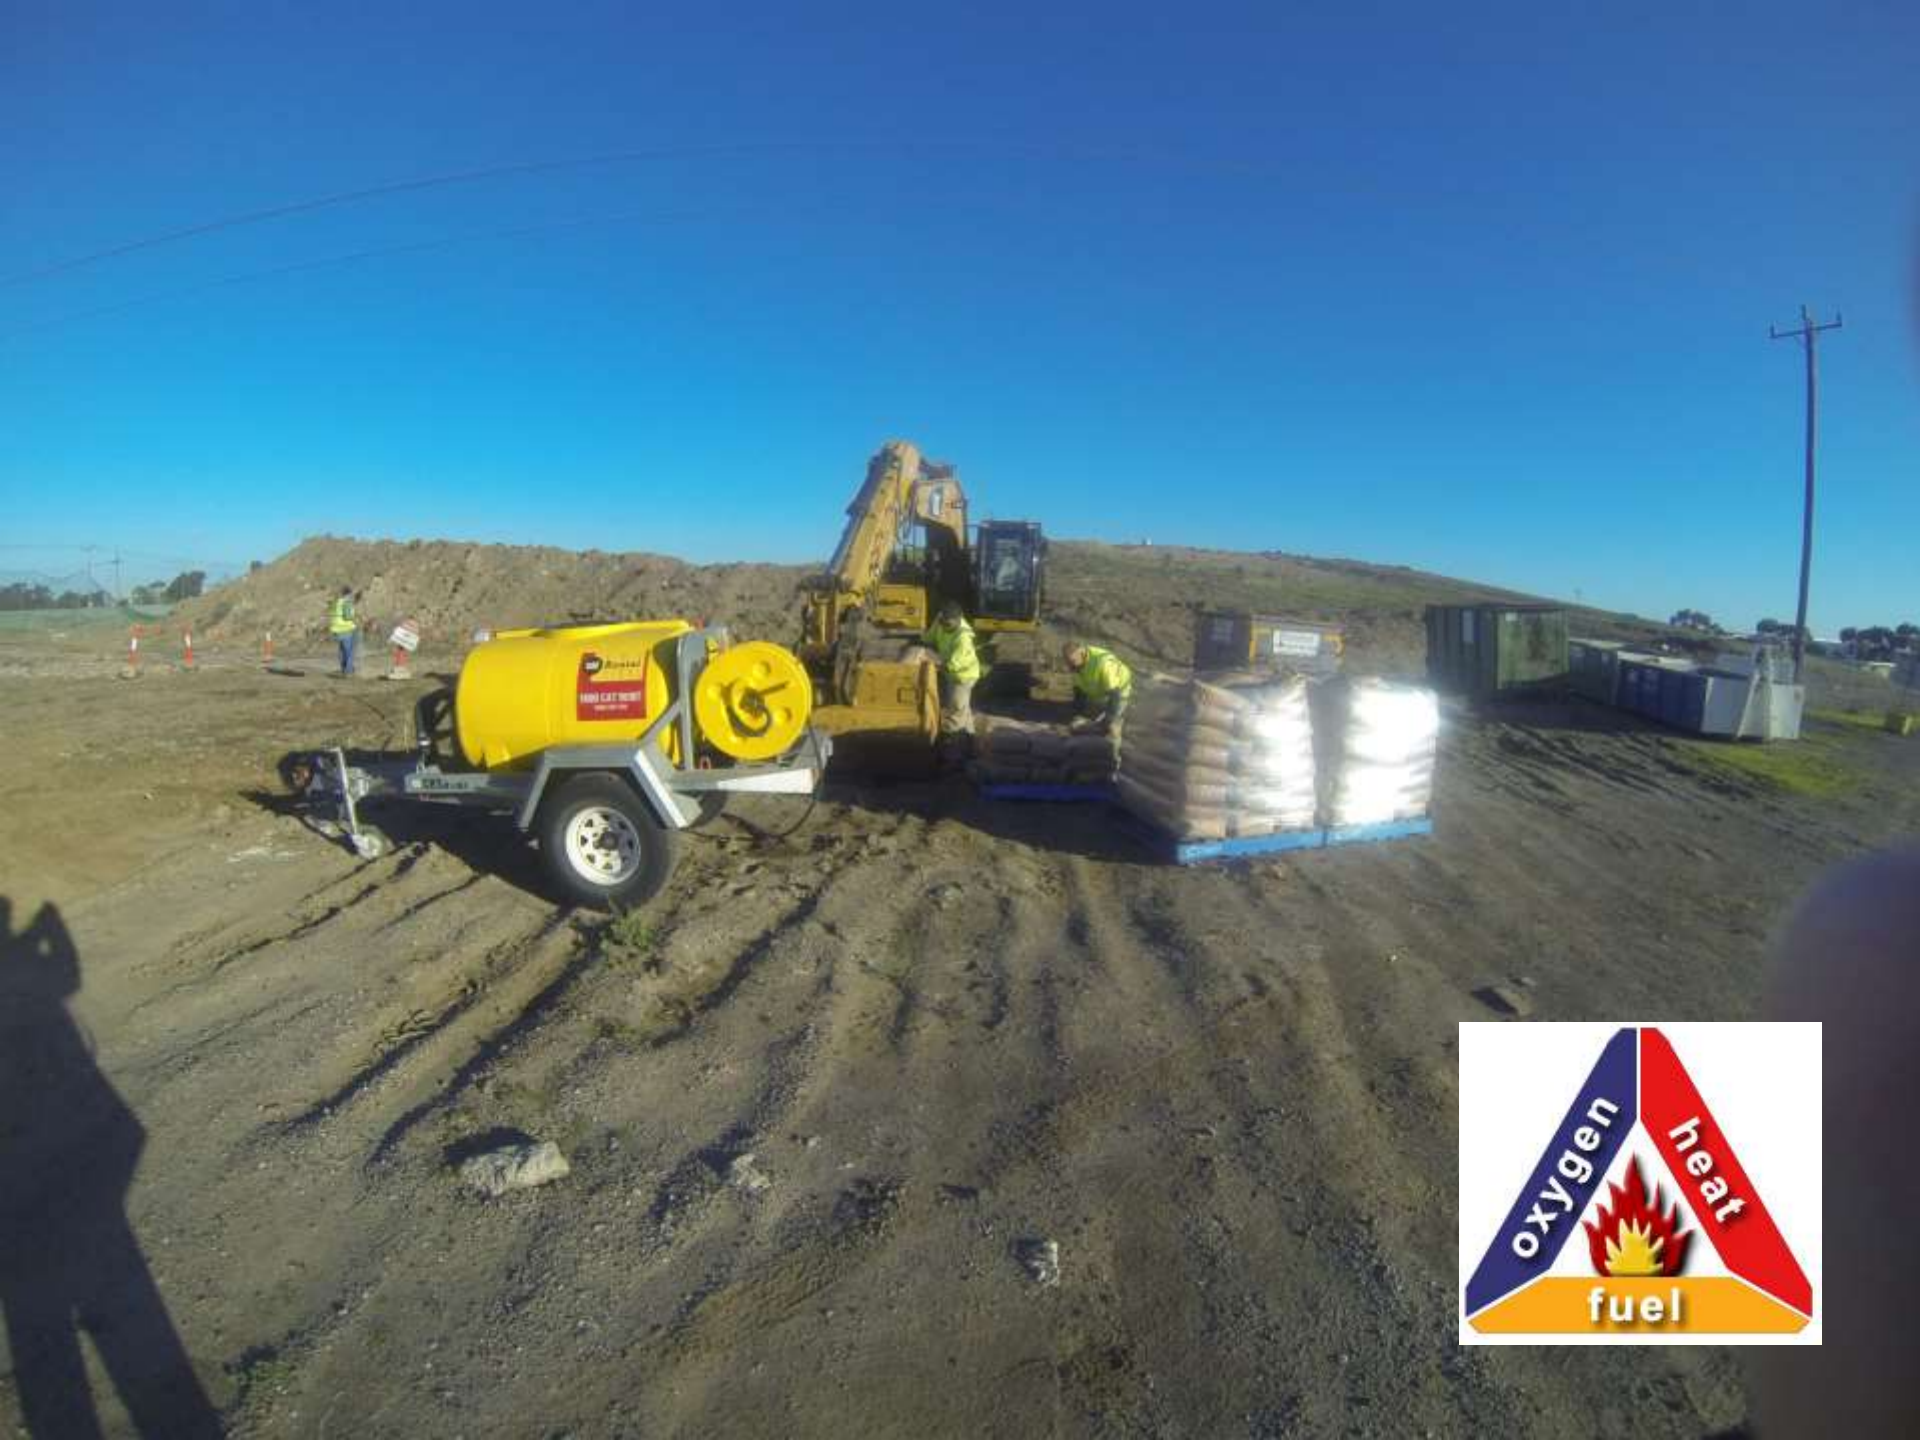
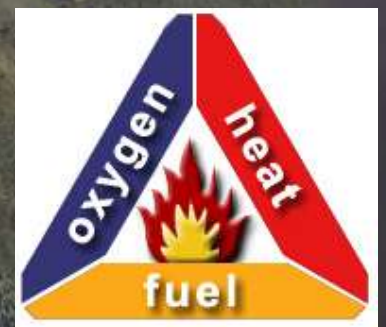
The initial corrective action activities, which also commenced immediately, included:

- Sealing and filling areas of surface settlement
- Sealing of perimeter areas (cracks around the edge of the quarry)
- Sealing of leachate risers
- Improving access around the perimeter of the site
- Assessing and improving stormwater drainage

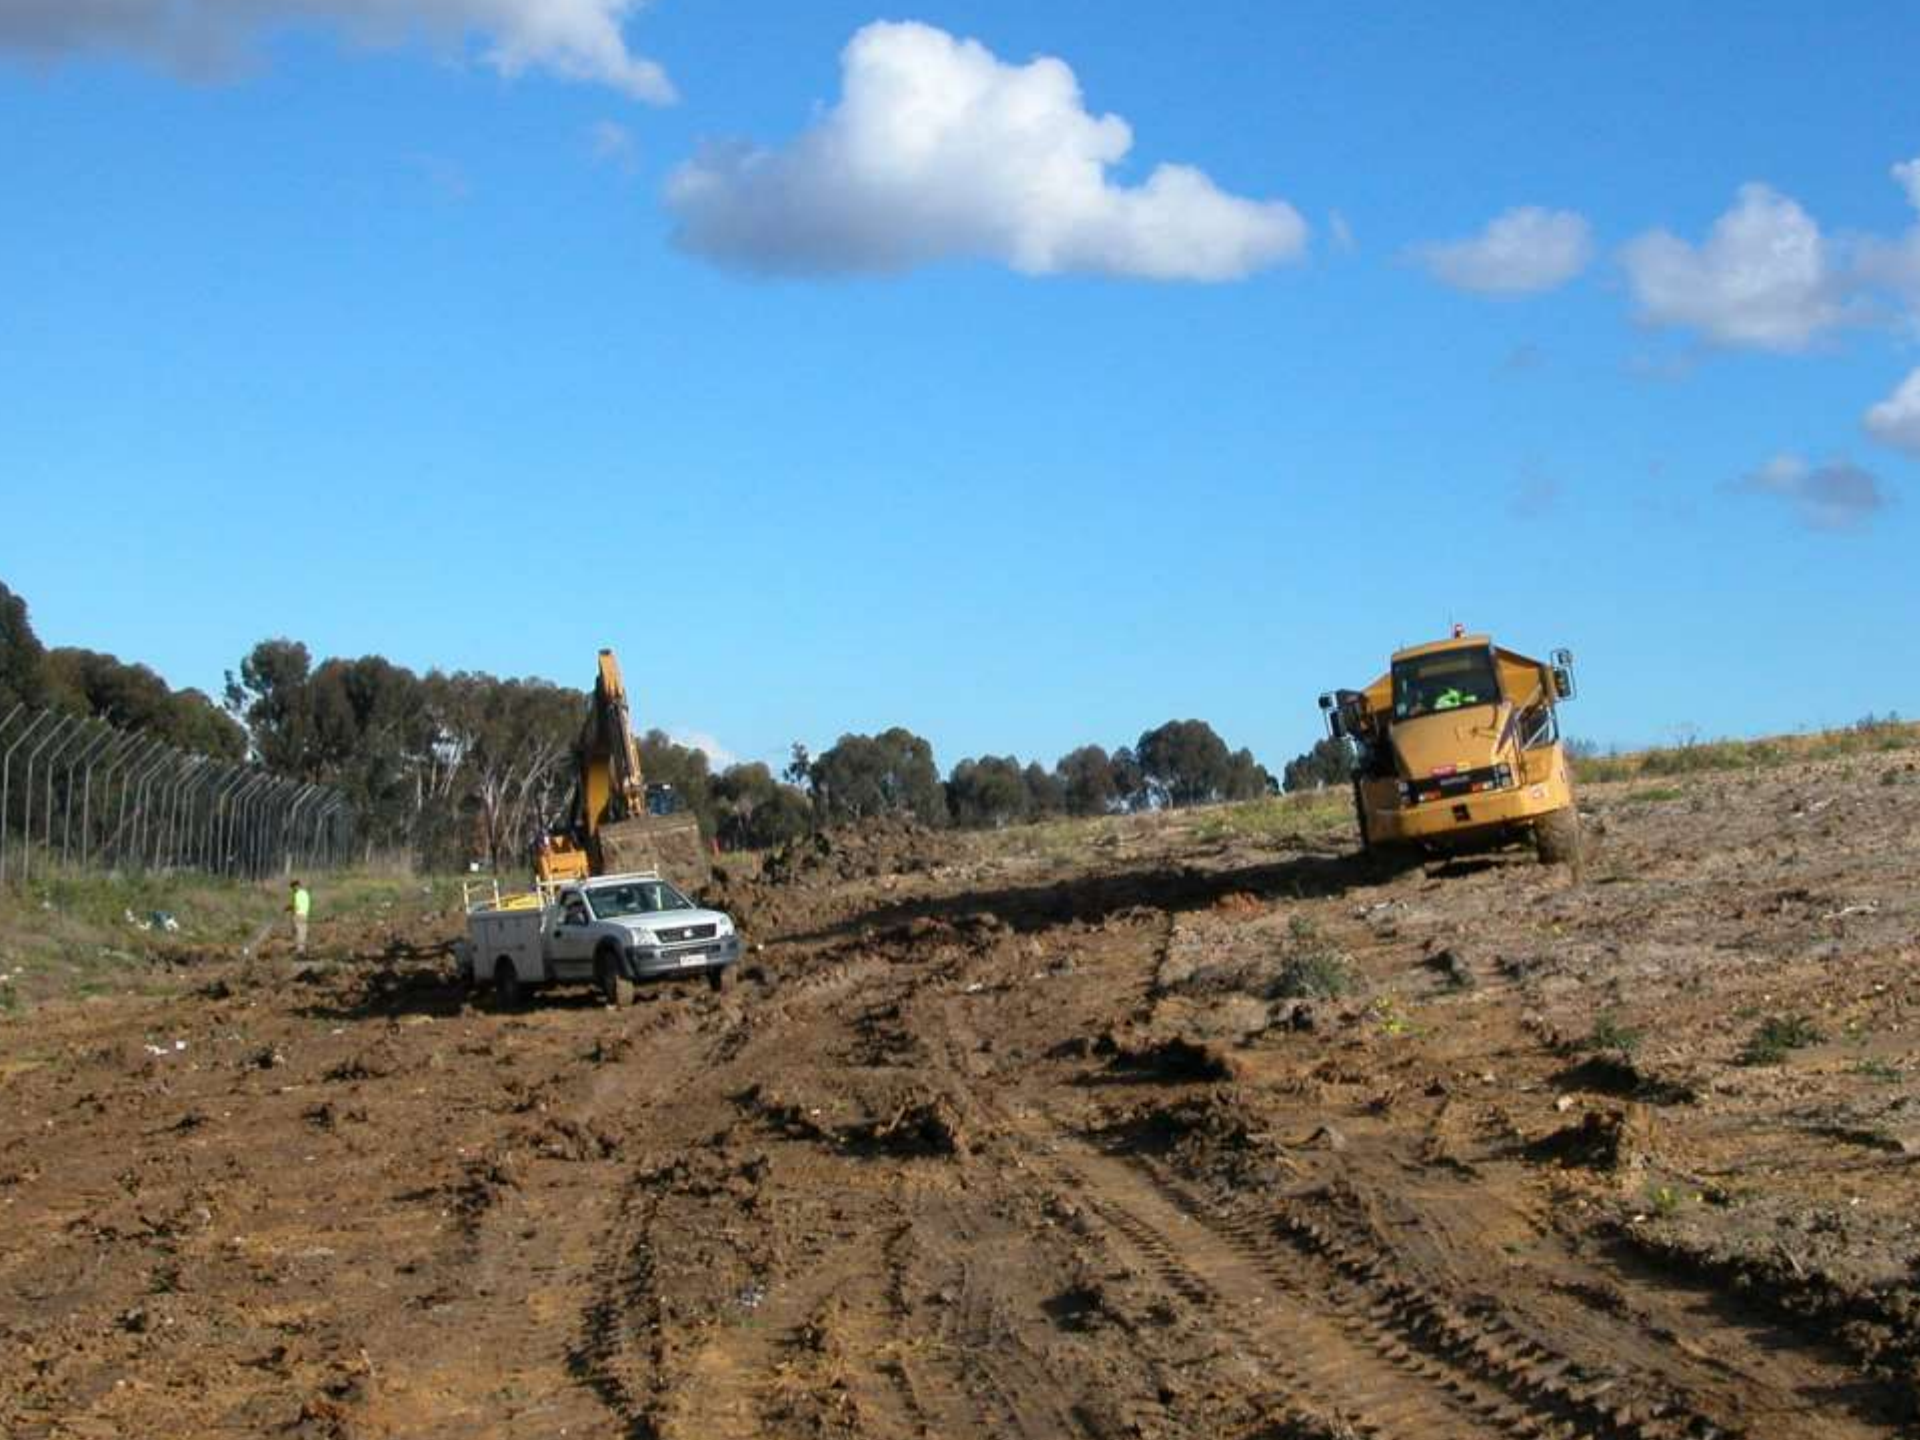
The long-term corrective action activities will include:

- **Rehabilitation or abandonment of the leachate risers**
- **Recovery of landfill gas (potentially for beneficial use)**
- **Establishment of final grades**
- **Placement of final capping and vegetation**
- **Management of stormwater**
